Document class Release Note
 Document ID 2NGB002551
 Business Unit ABB Oy, Distribution Solutions
 Page 1/3
 Date 11.12.2023

Firmware update release 1.3.2 for SSC600 1.0 Feature Pack 3

Firmware update release 1.3.2 is for the following product:

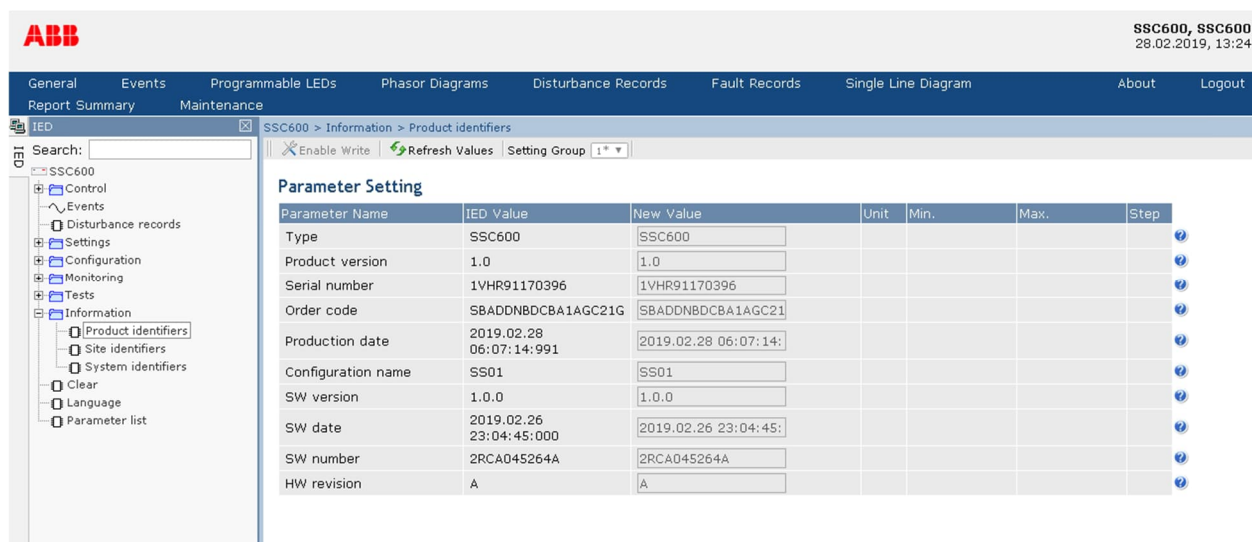
Fig. 2 Current firmware revision of the SSC600 product

To identify the current firmware revision of the SSC600, please refer to Fig. 2.

The screenshot shows the ABB WHMI interface for an SSC600 product. The 'Parameter Setting' table is visible, listing various parameters and their current values. The 'Order code' parameter is highlighted, showing the value 'SBADDNBDCBA1AGC21G'.
