# CoreSense M10

Release Notes – 0048-00-3-00005-01 Rev G

Software Version 1.4.1.32

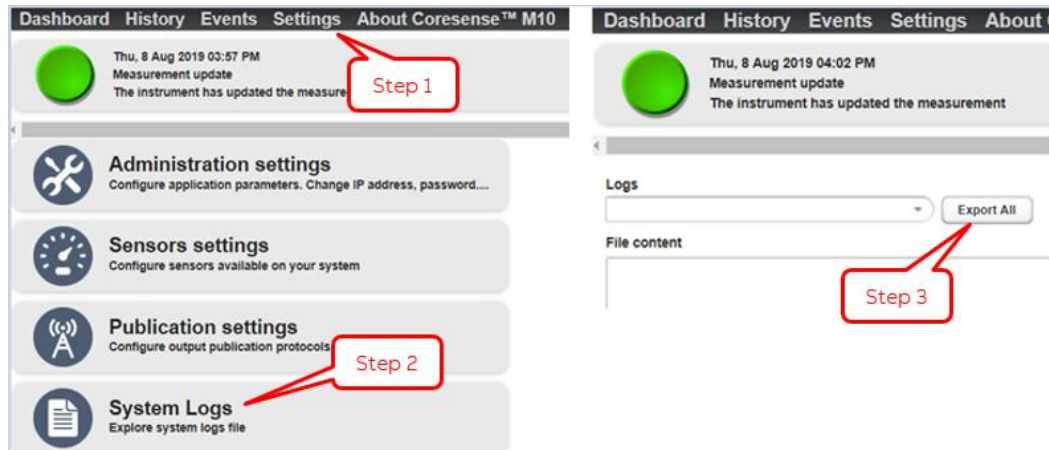
Figure 1. System logs.

1. Obtain the CoreSense M10 software images from ABB (see §0).
2. Open a web browser and enter the IP address of your system in the address bar. IP address is shown at the bottom of the CoreSense M10 local screen. Your computer must be configured in the same network subnet.
3. Click on the **Settings** tab and then click **System Logs**. Enter your password to gain access. The factory password is **Admin**.

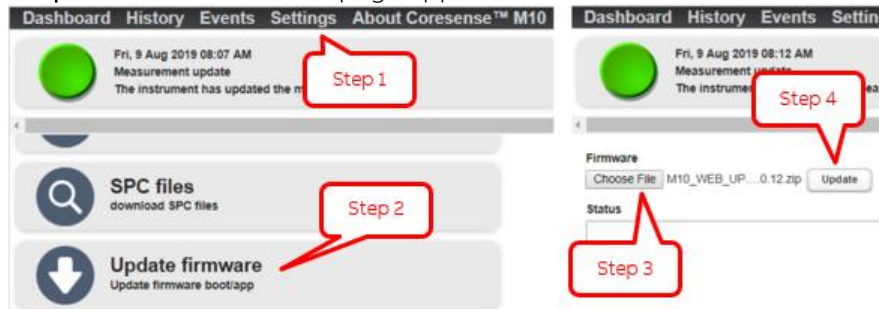
Figure 3. Update firmware.

6. Click **Settings** and **Update firmware**. A new page appears.

7. Click **Choose File** and select the M10\_WEB\_UPDATE\_1.4.1.32.zip file. Click **Open** and then **Update**. The update process will start and can last for few minutes. Messages will appear in the **Status** pane during the process and “Rebooting instrument now” will appear at the end of the process. The update is complete once a “Session Expired” red banner appears on the top of the web page.

1. Click **Settings** and **Update firmware** (see Figure 3). A new page appears.
2. Click **Choose File** and select the M10\_WEB\_H2SUpdate\_3.966J.zip file. Click **Open**, and **Update**. The update process starts and can last for few minutes. Messages will appear on the **Status** pane during the update process. It will be completed a few minutes after the “Rebooting instrument now” message. The update is complete once a “Session Expired” red banner appears on the top of the web page.
