ABB MEASUREMENT & ANALYTICS | TECHNICAL BULLETIN

Software Update

300 MHZ RMC-100

AUGUST 26, 2022 | 2106369TB-TB214 REV AB

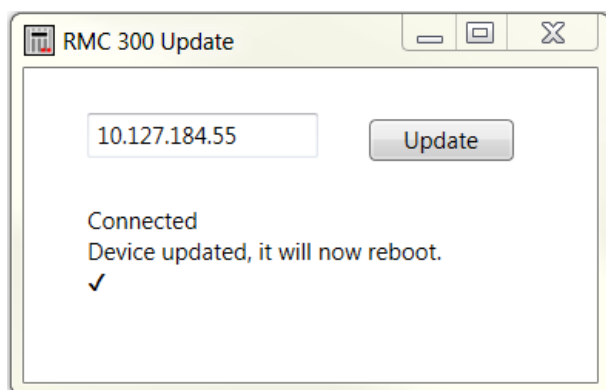
3. If the procedure is successful, the following messages are displayed as shown in the image below.
