Document class Release Note
 Document ID 2NGA000988
 Business Unit ABB Oy, Distribution Solutions
 Page 1/9
 Date 10.05.2021

Firmware update release 2.1.14 for 620 series IEC product version 2.0 FP1 protection relays

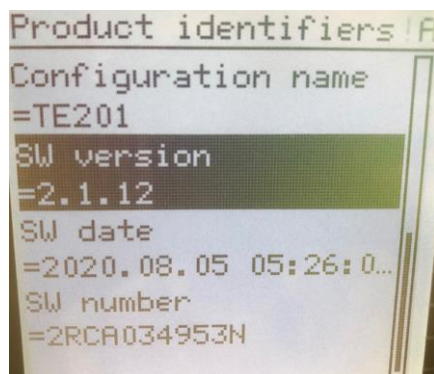
Fig. 2. Product identifiers of the 620 series protection relay

To identify the current firmware (SW) version of the 620 series protection relay, please refer to Fig. 2.
