Document class Release Note
 Document ID 1MRS759127
 Business Unit ABB Oy, Distribution Solutions
 Page 1/4
 Date 15.02.2019

Firmware update release 1.1.0.C2 for 630 series product version 1.1 protection relays

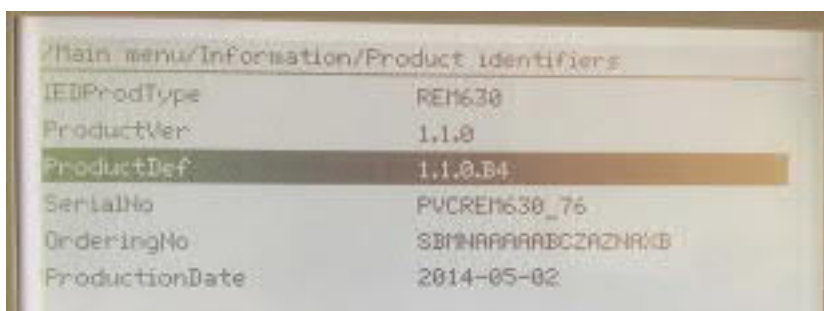
Fig. 2 Current firmware revision of the 630 series protection relay

To identify the current firmware revision of 630 series relays, please note the parameter **ProductDef**, refer to Figure 2.
