Document class Release Note
Document ID 2NGA001101
Business Unit ABB Oy, Distribution Solutions
Page 1/4
Date 21.09.2021

Firmware update release 3.0.10 for 615 series IEC product version 3.0 protection relays

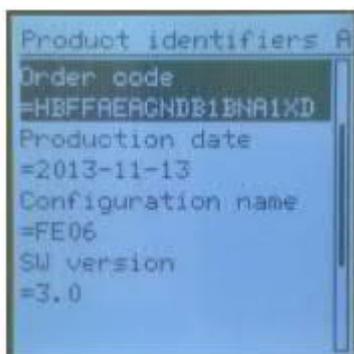
Fig. 2 Current firmware revision of the 615 series protection relay

To identify the current firmware revision of the 615 series protection relay, please refer to Fig. 2.
