Document class	Release Note
Document ID	2NGA001406
Business Unit	ABB Oy, Distribution Solutions
Page	1/10
Date	30.05.2022

Firmware update release 1.1.4 for REX640 control and protection

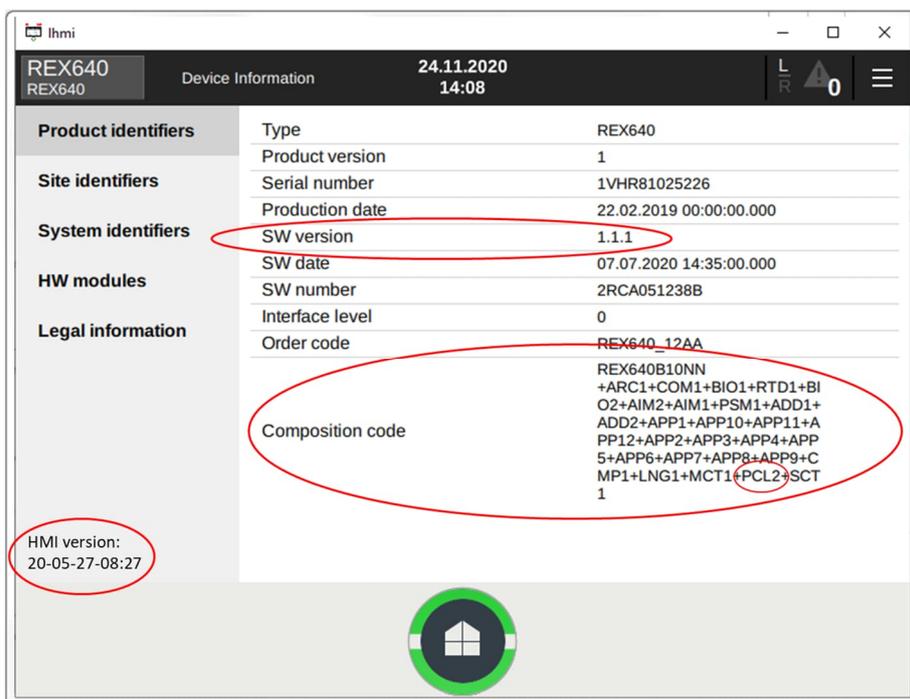
Fig 1. LHMI Device Information page

Following figures show how to locate the above-mentioned information from the LHMI Device Information page and from the WHMI Product Identifiers page. The LHMI Device Information page can be accessed by tapping the menu bar on upper part of the LHMI screen and locating the Device Information button from the lower left-hand corner of the screen. The relay Firmware version is referred as "SW version" and the LHMI application version is referred as "HMI version". The "PCL" part of the composition code is pointed out as well.
