Document class Release Note
 Document ID 2NGA001800
 Business Unit ABB Oy, Distribution Solutions
 Page 1/12
 Date 06.07.2023

Firmware update release 2.1.16 for 620 series IEC product version 2.0 FP1 protection relays

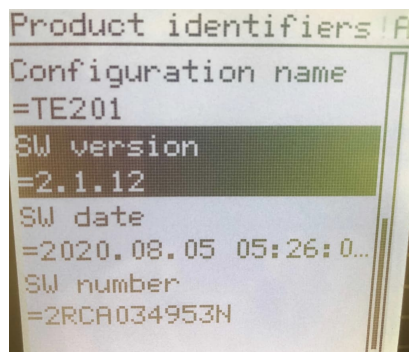
Fig. 2. Product identifiers of the 620 series protection relay

To identify the current firmware (SW) version of the 620 series protection relay, please refer to Fig. 2.
