RS-485 Troubleshooting guidelines

Identify common issues with communications

Network communication protocols such as BACnet MS/TP or Modbus use the RS/EIA-485 electrical standard for serial communication. These are just two network options available as embedded fieldbus (EFB) on the ACH580 series of variable frequency drives (VFD). Often field installers, technicians, integrator and even tech support encounter intermittent or persistent communication errors. This technical note will detail troubleshooting guidelines using features available within the ACH580 interface.

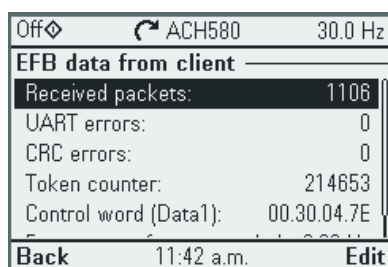
Figure 1: Primary settings, Embedded fieldbus

The ACH580 Primary settings menu organizes the configuration and diagnostics for communications parameters, see Figure 1. Access this menu by navigating to Menu > Primary settings > Communications > Embedded fieldbus > Communication setup or Diagnostics > EFB data from client.

Off		ACH580	30.0 Hz
EFB data from client			
Received packets:	1106		
UART errors:	0		
CRC errors:	0		
Token counter:	214653		
Control word (Data1):	00.30.04.7E		
Back	11:42 a.m.	Edit
