Document class      Release Note  
 Document ID        2NGA000651  
 Business Unit       ABB Oy, Distribution Solutions  
 Page                1/5  
 Date                 23.09.2020

## Firmware update release 1.3.0.A9 for 630 series product version 1.3 protection relays

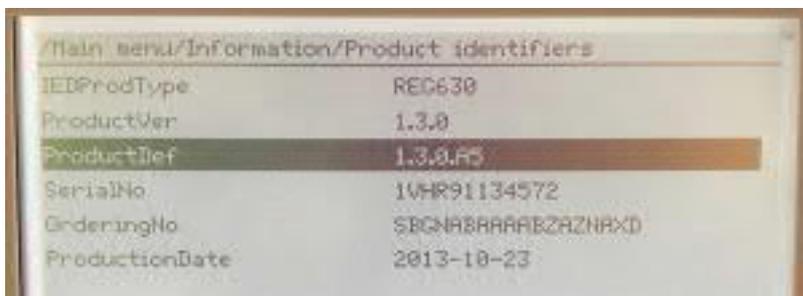
*Fig. 2 Current firmware revision of the 630 series protection relay*

To identify the current firmware revision of 630 series relays, please note the parameter **ProductDef**, refer to Figure 2.
