Document class Release Note
Document ID 2NGA000053
Business Unit ABB Oy, Distribution Solutions
Page 1/5
Date 20.6.2019

Firmware update release 4.1.7 for 615 series IEC product version 4.0 FP1 (E) protection relays

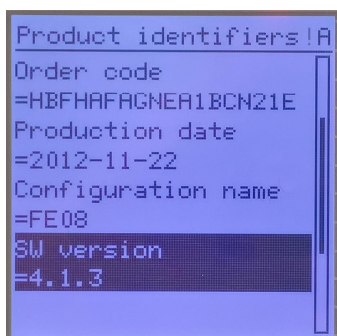
To identify the current firmware (SW) revision of the 615 series protection relay, please refer to Fig. 2.

Fig. 2. The firmware revision of the 615 series protection relay
