Document class Release Note
 Document ID 2NGA000060
 Business Unit ABB Oy, Distribution Solutions
 Page 1/6
 Date 07.05.2019

Firmware update release 2.0.11 for 620 series product version 2.0 (F) protection relays

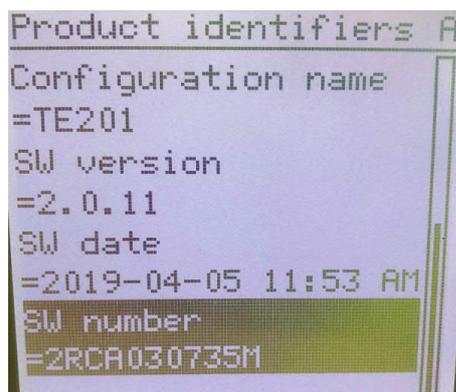
Fig. 2. The firmware revision of the 620 series protection relay

To identify the current firmware (SW) revision of the 620 series protection relay, please refer to Fig. 2.
