Document class Release Note
 Document ID 2NGA000987
 Business Unit ABB Oy, Distribution Solutions
 Page 1/6
 Date 17.03.2021

Firmware update release 2.0.12 for 620 series product version 2.0 (F) protection relays

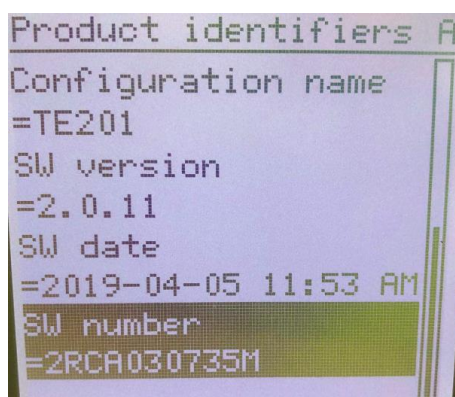
Fig. 2. The firmware revision of the 620 series protection relay

To identify the current firmware (SW) revision of the 620 series protection relay, please refer to Fig. 2.
