Document class	Release Note
Document ID	2NGA000928
Business Unit	ABB Oy, Distribution Solutions
Page	1/5
Date	01.03.2021

Firmware update release 1.1.3 for REX640 control and protection

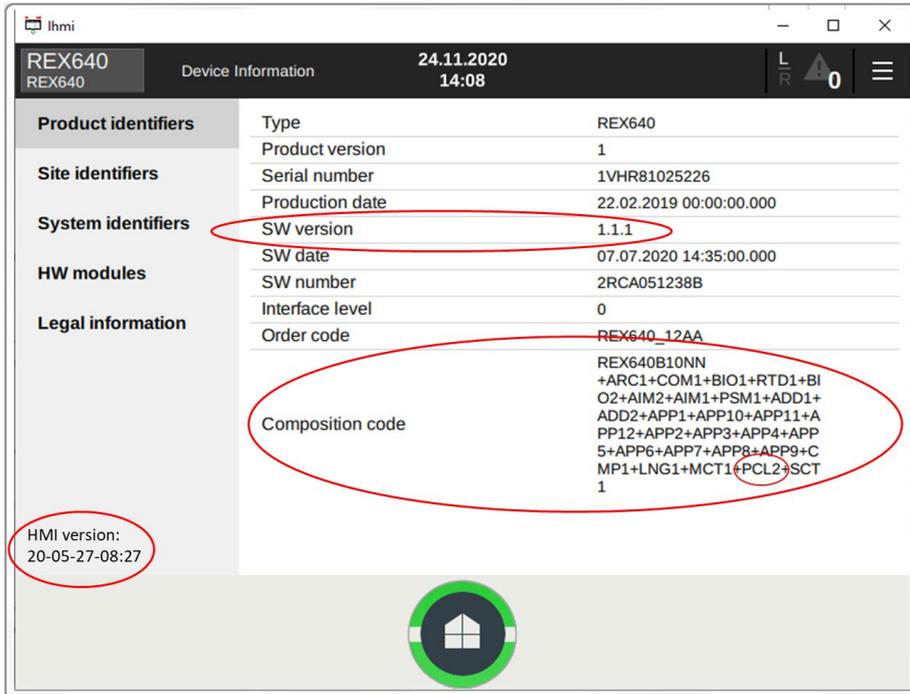
Fig 1. LHMI Device Information page

Below figures show how to locate the above-mentioned information from the LHMI Device Information page and from the WHMI Product Identifiers page. The LHMI Device Information page can be accessed by tapping the menu bar on upper part of the LHMI screen and locating the Device Information button from the lower left-hand corner of the screen. The relay Firmware version is referred as "SW version" and the LHMI application version is referred as "HMI version". The "PCL" part of the composition code is pointed out as well.

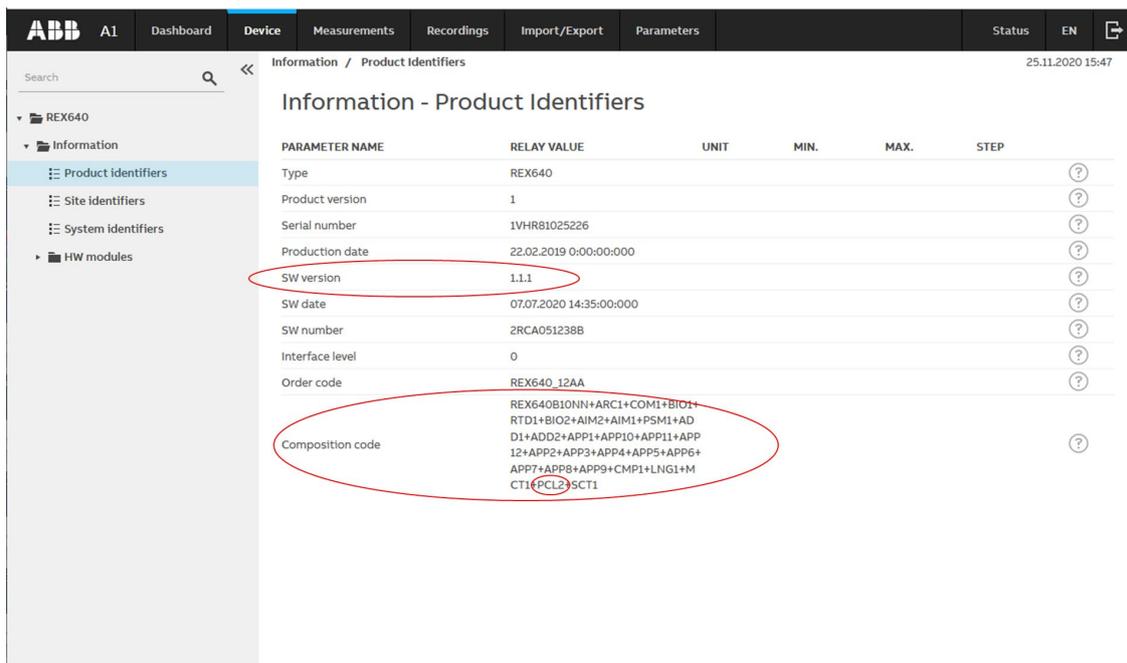
Fig 2. WHMI Product Identifiers page
