Document class Release Note
Document ID 2NGA001052
Business Unit ABB Oy, Distribution Solutions
Page 1/6
Date 12.08.2021

Firmware update release 2.0.4 for 611 series IEC product version G protection relays

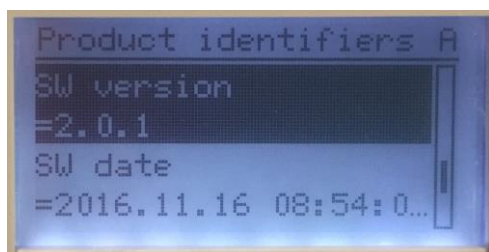
Fig. 2 Current firmware revision of the 611 series protection relay

To identify the current firmware revision of the 611 series protection relay, please refer to Fig. 2.
