Document class Release Note
 Document ID 2NGA002437
 Classification Public
 Business Unit ABB Oy, Distribution Solutions
 Page 1/5
 Date (dd.mm.yyyy) 12.12.2024

Firmware update release 6.0.1 for REX615 PCL1 protection and control relays

Update release 6.0.1 concerns REX615 PCL1 protection relay.

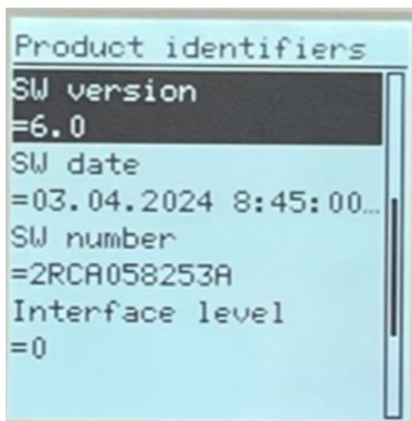
Following figures show how to locate the above-mentioned information from the LHMI Device Information page and from the WHMI Product Identifiers page. The relay Firmware version is referred as “SW version”. The “PCL” part of the composition code is pointed out as well.

Fig 1. LHMI Product Identifiers menu
