Teeside Beam Mill Case study: Marking

Two ABB IRB 6400 'FoundryPlus' six-axis robots, operated by Corus Group's Construction & Industrial Division at its Teesside Beam Mill to carry out marking operations on structural steel products, are proving to be a blueprint for safety and efficiency in one of industry's harshest environments.

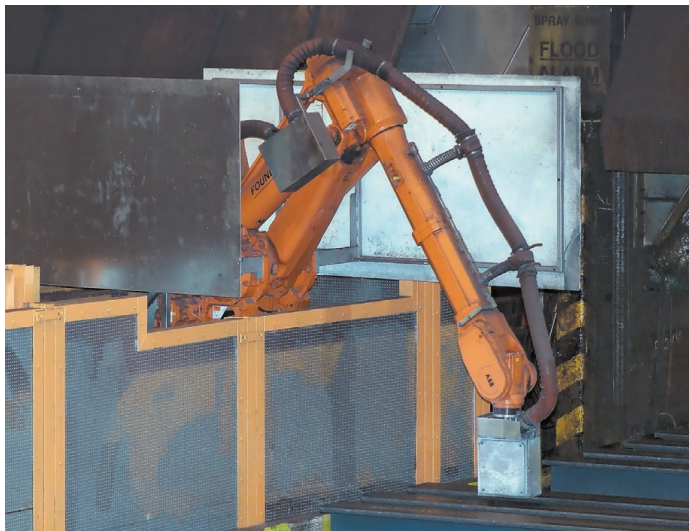
Teeside Beam Mill

The robot-based systems, installed during the mill's planned summer shutdown of 2003, are located at an optimum point in the product manufacture – within each of the two cooling banks, after the hot saw process. Control interlocks are incorporated to signal a halt to each product on its journey to the cooling banks, and while the product is stationary, the independently operated robots are signalled to power-up, carry out the marking operation, and return to their respective
