<b>ABB</b>	<b>Technical Note</b>		DOCTNACS60019	
	<b>RFI filter B84143-A600-S9 (10025451)</b>			
	Issued by	Date	Language	Revision
ABB Oy, Product Support	17.12.2009	en	B	1 (2)
Creator name	Ari Niskanen	Distribution	Public

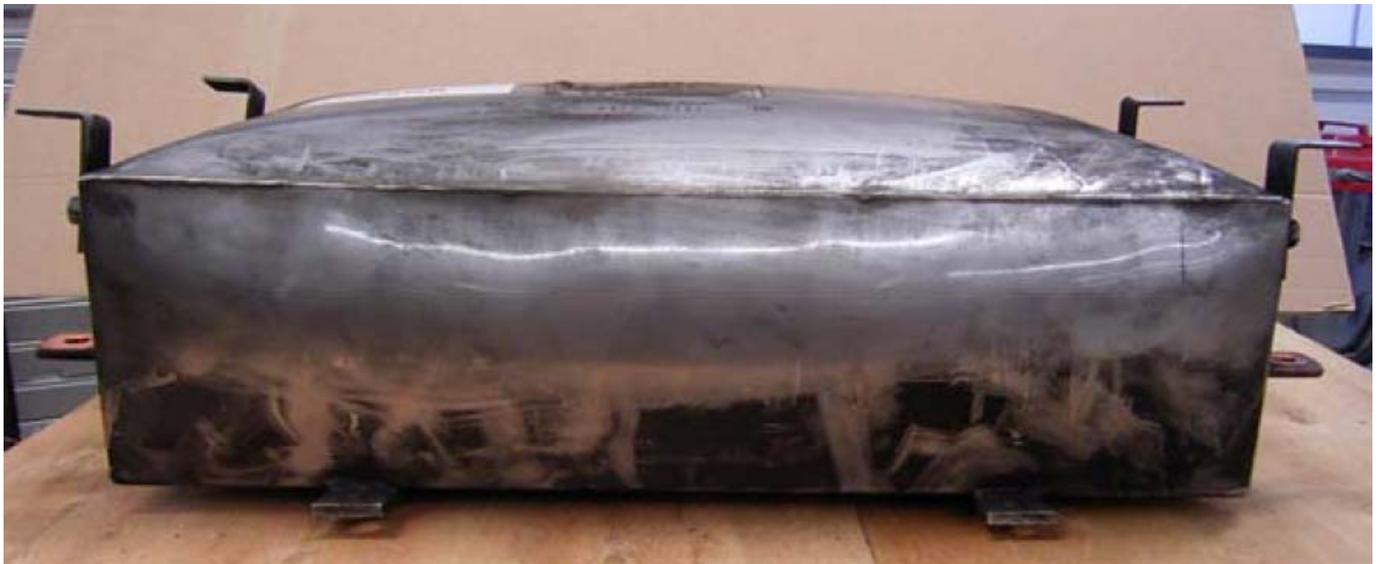
It has been detected problems with installations that use the **RFI FILTER B84143-A600-S9 (10025451)** manufactured between 1996 and 2000. These failures have their origin by combination of external technical facts. As harmful effect a defected filter capacitor can cause deformation to the RFI filter. In the worst case the RFI filter can explode as there are no safety vents to release the pressure in a controlled way.

*Picture1. Heavy deformation of RFI filter*

1. If during visual inspection the filter is found to be deformed by internal pressures, it is strongly advised to remove the RFI filter immediately.

Note: A temporary solution is to run the system without RFI filter.

## 2. Create a plan to replace the existing filter with new type of Epcos RFI filter
